Manhole Inspection Summary

Manhole # S53M__018MH

Insp Date: **4/4/08 9:32 AM**

Location Address: **928 Robinson St**

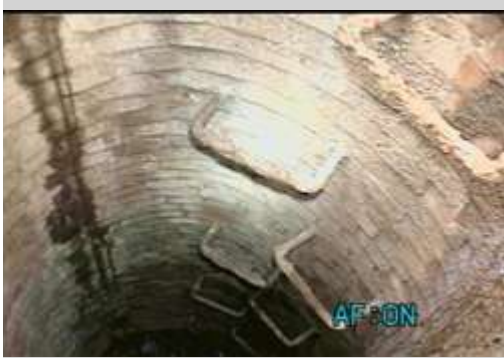
Defect 2

Steps Count: **8** Missing: **0** ☒ **Corroded**

corroded stairs

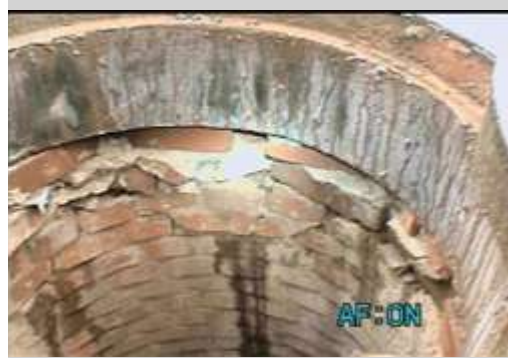
Defect 1

Condition: ☐ Sound ☐ Cracked ☐ Root Intrusion ☒ **Loose Brick** ☒ **Deteriorated**

Infiltration: ☐ None ☐ Joint ☐ Cracks ☐ Mortar ☐ Roots ☒ **Wall**

infiltration from loose brick in chimney

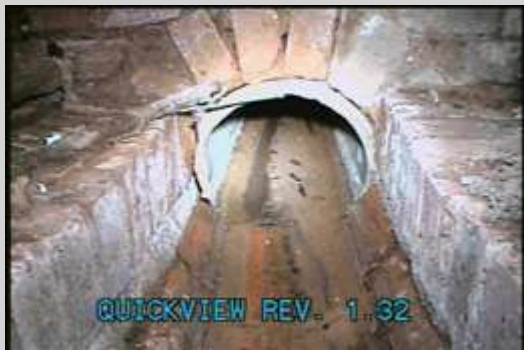
12 O'Clock Outflow

8 in. Circular Gravity Sewer
Pipe Out @ 12 O'Clock

Pipe Material: **Clay** ☐ Pipe Lined

Invert Depth: **12.08** (ft.) Flow Characteristics: **Fast**

Infiltration: **None** Pipe Seal Cond: **Unknown**

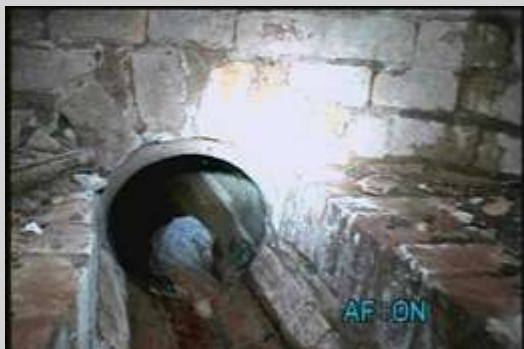
4 O'Clock Inflow

8 in. Circular Gravity Sewer
Pipe In @ 4 O'Clock

Pipe Material: **Clay** ☐ Pipe Lined

Invert Depth: **11.86** (ft.) Flow Characteristics: **Fast**

Infiltration: **None** Pipe Seal Cond: **Unknown**
